Client: **Central Processing – Auckland, NZ**  
Service: **Compressed Air & Vacuum Leak Survey carried out 23<sup>rd</sup> – 26<sup>th</sup> Mar**

The compressed air / vacuum leak survey under-taken on the above mentioned dates resulted in **288** air leaks and zero vacuum leaks being identified.

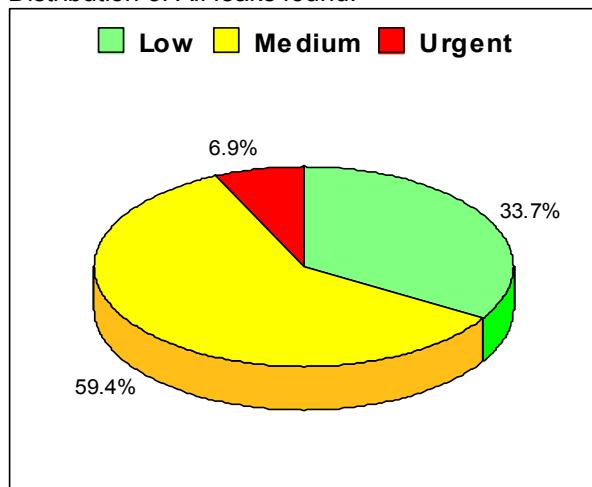
Distribution of All leaks found:

The attached Log provides comprehensive information pertaining to the location of each leak and a brief description of the nature of the leak. All leaks exceeding 80dB have been logged as Urgent and are also listed in a separate worksheet sorted by location to assist you with prioritising your maintenance program. Further information on individual leaks is written on a Green high visibility "Leak" identification tag supplied by ULDS Ltd and is attached to the source of each leak.

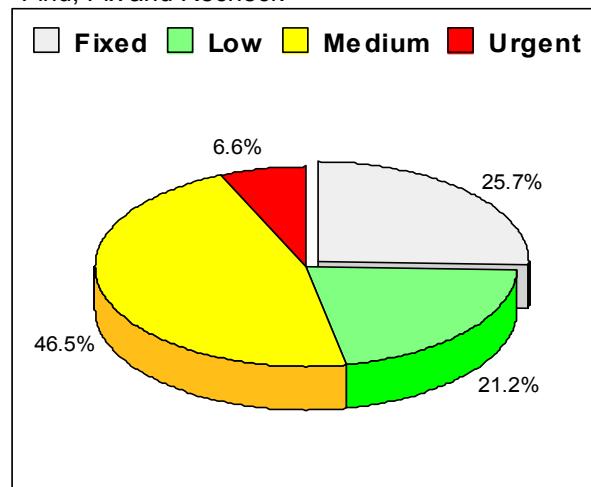
During the survey we used the "Find, Fix and Recheck" method which resulted in **25.7%** of the leaks found being repaired. This equates to an estimated immediate power saving of **\$14,773 pa**.

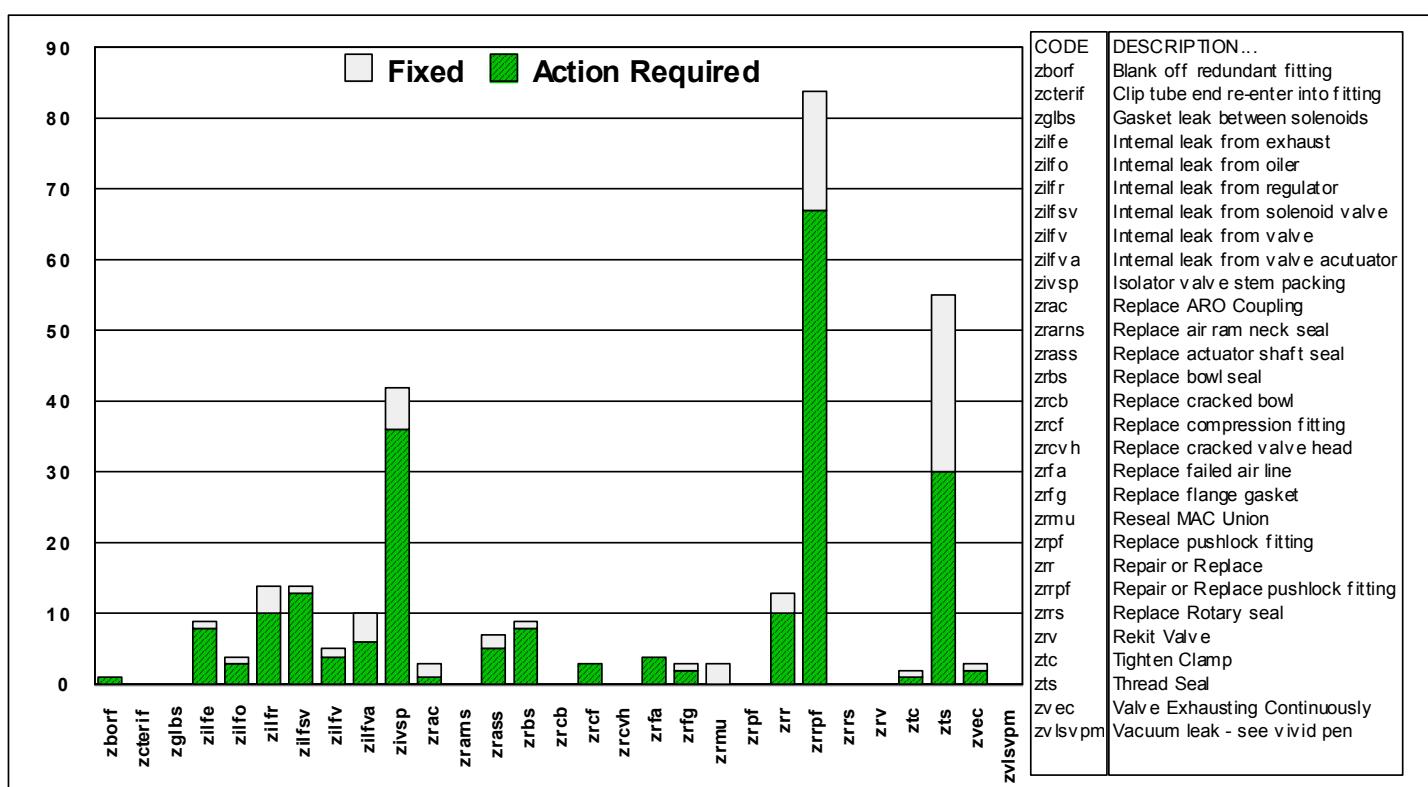
To assist you further in you're on going maintenance program, you will see below a count of all the fix codes that appear in the attached log. This is to help your engineering staff in identifying common causes which could be included in your preventive maintenance program.

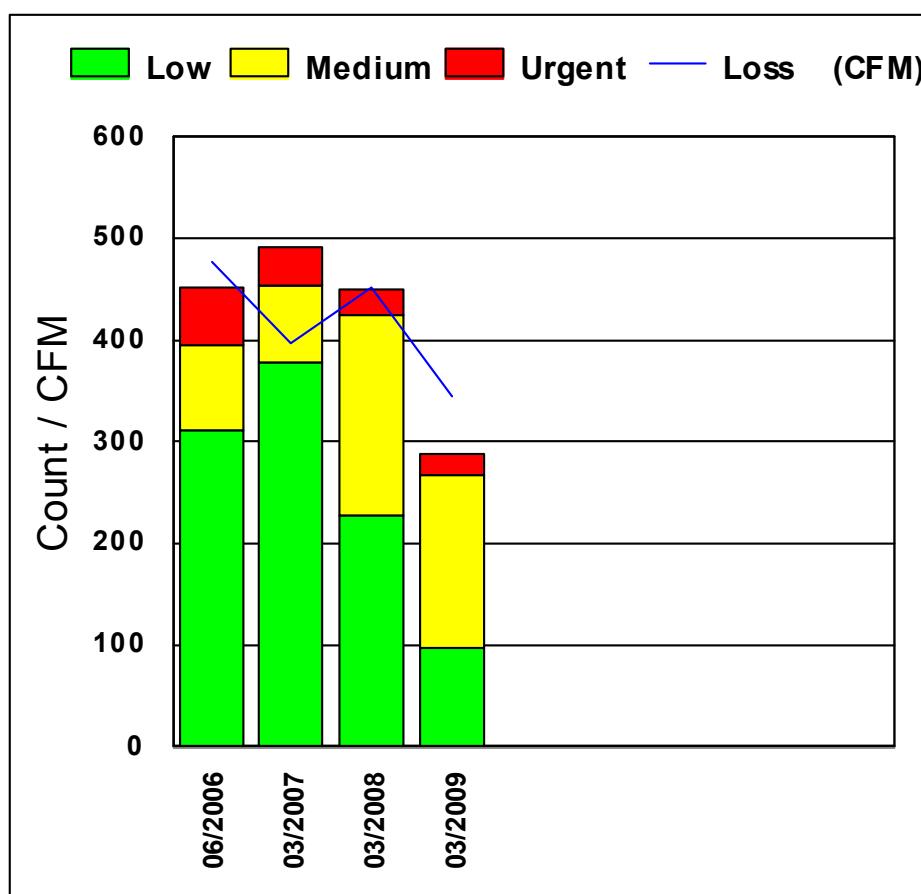
### Site Survey History:

The total number of leaks found during this year's survey has dropped 36%. This includes a 57% drop in Low leaks and Urgent leaks dropping 23%. This has resulted in a decrease in the overall air loss i.e. down from 27.0% to 20.6% which is now below the industry standard of 25%.

It was also noted that the number of leaking isolating values throughout the site has dropped further from 84 to 42. This figure was 149 in the 2007 survey. Please note, a number of cabinets in Rm206 were not checked due to a pending upgrade in this area.
